PROJECT SUMMARY

Cobb County Soil & Water Conservation District Demonstration Project Shaw Park Stream Restoration/Stabilization

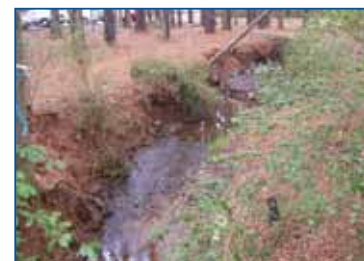
Typical streambank erosion and undercutting prior to restoration.

In an effort to demonstrate techniques that could be performed by the individual homeowner utilizing minimal mechanized assistance, a series of Soil-Bioengineering methods were implemented to address ongoing erosion within the streambanks. These techniques included the installation of a brush mattress system to protect an opposing streambank from stormwater flows emanating from an upstream culvert outfall, as well as the installation of a Vegetation Reinforced Soil System. This system utilized coconut fiber BioD Block geo-textiles to “re-build” a portion of the streambank that had been eroded and undercut due to increases in stormwater influences.

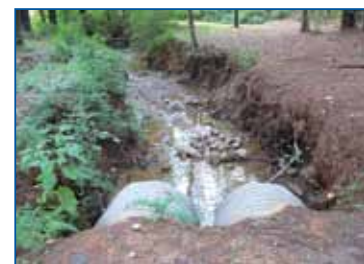
View of culvert outfall and associated scour hole prior to restoration.

Critical to the overall success of the plan included the “daylighting” of the stream by the removal of the existing culvert crossing and creation of a stable channel slope and profile through the installation of four (4) rock vane grade control structures. Further channel instability was addressed throughout the reach utilizing natural materials through the installation of log “K” dams and log vane grade controls.

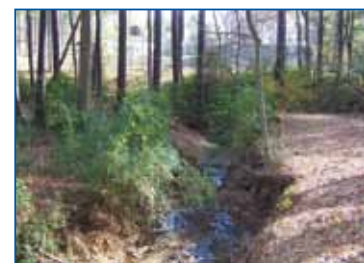
Riparian buffer dominated by pine trees and exotic invasives.

In addition to the mechanical or engineered stream restoration techniques showcased, the project involved vegetative restoration practices. Through the installation of native plant species including a mixture of trees, shrubs, forbs and native grasses, the natural vegetative stream buffer was comprehensively restored. This portion of the project also included efforts to control the presence of exotic invasive species.

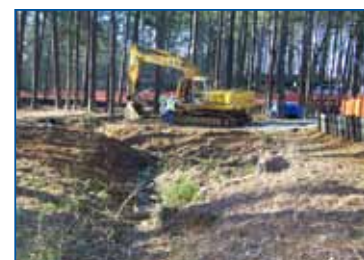
Project begins with site clearing and erosion and sediment control BMPs.

Due to unseasonably heavy rainfall and other unforeseen delays, restoration activities began on the site the last week of March 2010. Initial tasks included establishing all appropriate erosion and sediment control Best Management Practices; site access; and rough clearing and grubbing of critical project areas. The demonstration site utilized an array of stream restoration techniques to address a number of actively eroding areas within both the active stream channel and

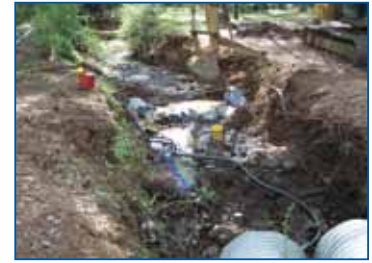
Installation of rock vane grade control.

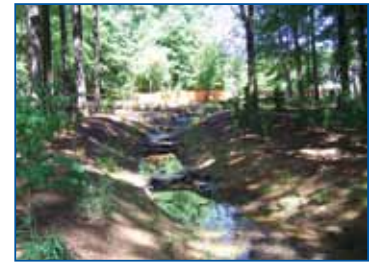
View of culvert crossing after removal with rock vanes in place.

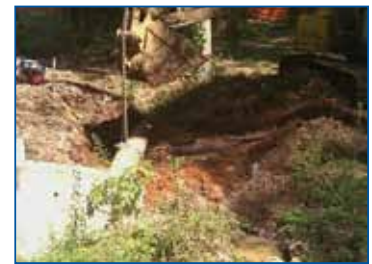
Installation of Log K dam.

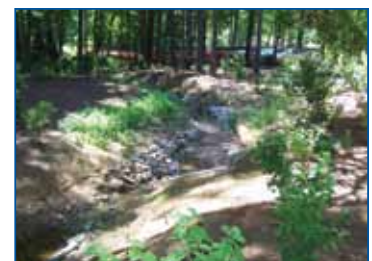
View of completed brush mattress and VRSS soil bio-engineering.

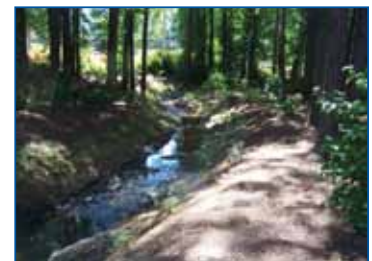
Riparian buffer vegetation installation completed.
